# Manhole Inspection Summary

## Manhole # S21WW1046MH

Record Plat: **21WW1** Node: **046** Status: **Found**

Insp Date: **12/3/06 12:25 PM**

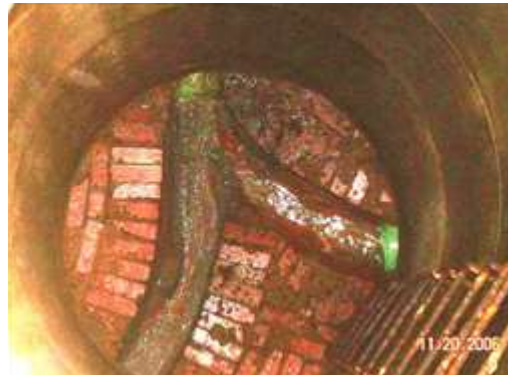
Top View

Bench debris.

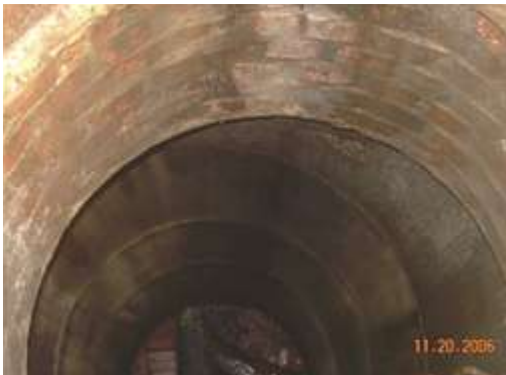
Defect

Frame leaks. Adjustment root intrusion and infiltration. Corbel and Barrel infiltration.

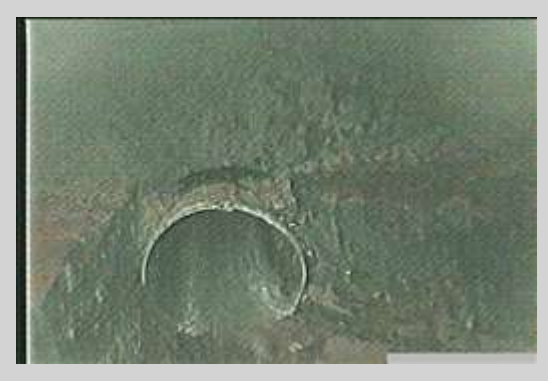
### 8 in. Circular Gravity Sewer Pipe Out @ 12 O'Clock

Comments **The O12 and the I3 pipe seals are not flush to the pipe.**

Barrel deterioration and infiltration.
